Manhole Inspection Summary

Manhole # S130__018MH

Location Address: **3013 Fredrick rd** Cross Street: **S Longwood St**

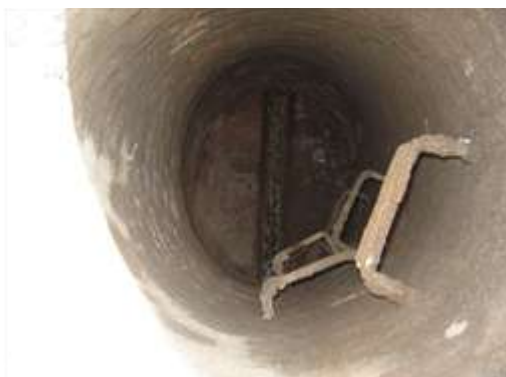
Defect 1

Infiltration: ☐ None ☐ Joint ☐ Cracks ☒ **Mortar** ☐ Roots ☐ Wall

Steps Count: **6** Missing: **0** ☒ **Corroded**

corroded steps/infiltration at corbel and barrel

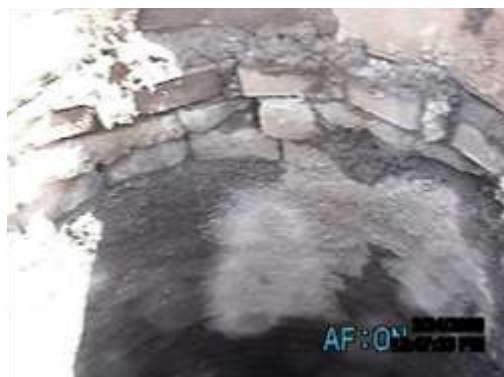
Defect 2

Condition: ☐ Sound ☐ Cracked ☐ Root Intrusion ☐ Loose Brick ☒ **Deteriorated**

Infiltration: ☐ None ☒ **Joint** ☐ Cracks ☒ **Mortar** ☐ Roots ☒ **Wall**

deteriorated chimney, signs of infiltration
missing mortar/ frame-chimney joint

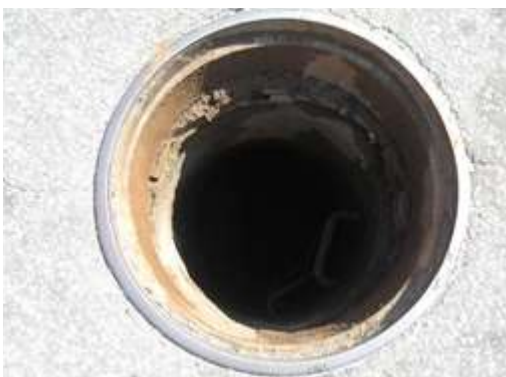
Defect 3

Frame Offset: **2** (in.) Condition: ☐ Sound ☐ Cracked ☒ **Leaks**

frame leaks and offset

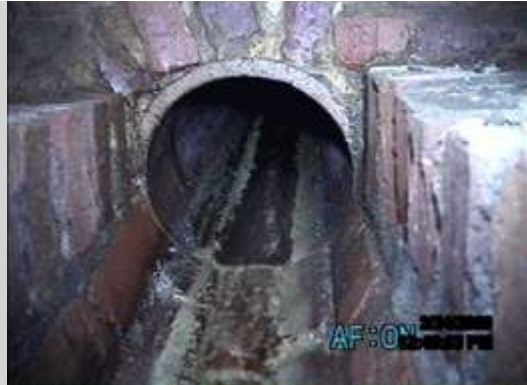
12 O'Clock Outflow

Pipe Height: **8.4** (in.) Rod and Bar (Angled)
Pipe Material: **Clay** ☐ Pipe Lined
Invert Depth: **12.08** (ft.) Flow Characteristics: **Slow**
Deposits: ☒ None ☐ Mud ☐ Sludge ☐ Debris ☐ Grease
Silt Depth: **0** (in.) Deposits Extent:
Infiltration: **None** Pipe Seal Cond: **Sound**

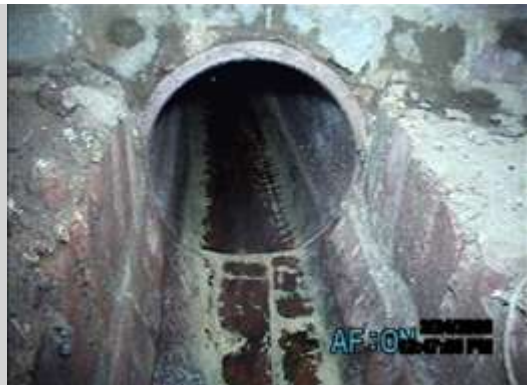
6 O'Clock Inflow

Pipe Height: **8.4** (in.) Rod and Bar (Angled)
Pipe Material: **Clay** ☐ Pipe Lined
Invert Depth: **11.40** (ft.) Flow Characteristics: **Slow**
Deposits: ☒ None ☐ Mud ☐ Sludge ☐ Debris ☐ Grease
Silt Depth: **0** (in.) Deposits Extent:
Infiltration: **None** Pipe Seal Cond: **Sound**
